1. REPORT DATE 29 OCT 2008		2. REPORT TYPE		3. DATES COVE 00-00-2008	RED 3 to 00-00-2008	
4. TITLE AND SUBTITLE				5a. CONTRACT NUMBER		
Sadr City R3 Water Treatment Plant Baghdad, Iraq			5b. GRANT NUMBER			
				5c. PROGRAM ELEMENT NUMBER

Summary of Report: PA-08-143

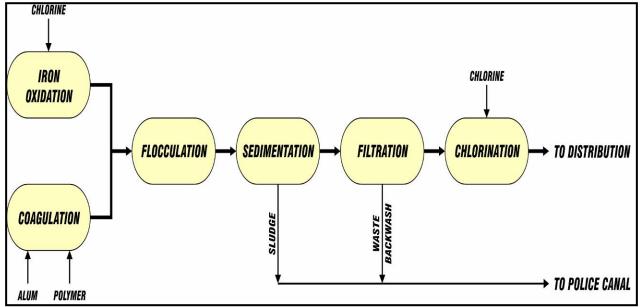
Figure 1. Treatment process overview

The contractor provided a process flow design for the Sadr City R3 WTP. The source of raw water supply for the WTP is the Tigris River via the existing raw water distribution system. Raw water from the Tigris River is conveyed from the Shark Dijlah water pump station to the vicinity of the plant site by an existing raw water transmission pipeline. The raw water enters the raw water metering control stations where it is pumped to the rapid mix tanks. The water is then chlorinated as it is conveyed to the rapid mix tanks, where alum and polymer are added to facilitate the flocculation and coagulation of solids. The alum forms small gel-like precipitate that traps suspended solids and forms sediments that settle easier than normal solids. The well mixed water flows slowly through the flocculation/sedimentation basins where it outlets through the effluent channel. The settled solids are collected from the bottom of the tank and ultimately are pumped to a drainage canal as sludge. The effluent water from the sedimentation basins is further chlorinated as it flows to the filters. The filters are made of granular media material. The filters remove additional solids—those that did not settle out in the clarifier. The filtered water is once again chlorinated and then stored in the treated water storage tanks. Since the potable water must be conveyed to the end users, there is a system of four pumps that pump the water from the storage tanks into the distribution lines for conveyance to the residents (Figure 1).

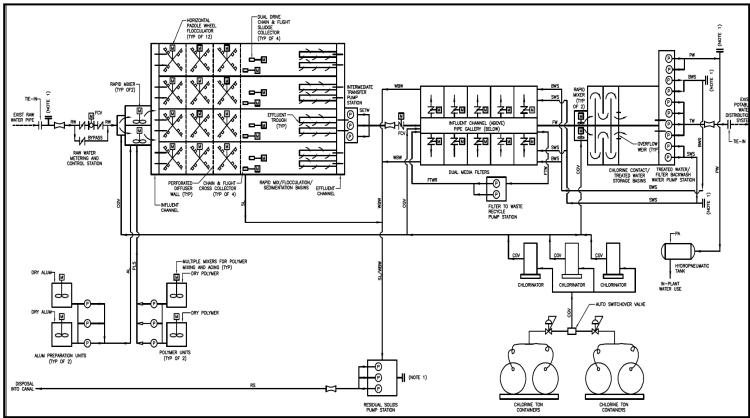
Figure 2. Process flow diagram

The treatment processes, shown in Figure 2, already constructed include: the raw water metering and control; the coagulation rapid mix tanks; the operations building, the flocculation sedimentation basins, the intermittent transfer pump station, the chemical building, the filter structure, the residual solids pump station, the filter waste recycle pump station, the chlorine contact treated water storage tanks, the outlet pump station, the generators, the electrical facility, the perimeter wall, and the guard house. Three structures primarily comprise these facilities: (1) rapid mix/flocculation/sedimentation/intermediate transfer pump station is one common structure; (2) the filter structure is the second; and (3) the chlorine mix/chlorine contact tank/treated water storage/treated water pumping is the third.

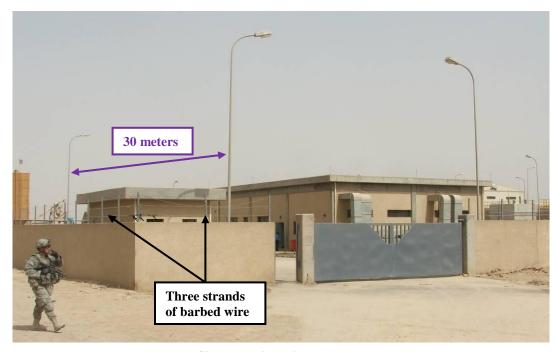
Site Photo 5. Operator building

The Operator building provides the administrative and maintenance support functions for the plant (Site Photo 5). The design required an electrical room, kitchen, two supervisor's rooms, a file room, a repair shop, and a laboratory (Figure 3).

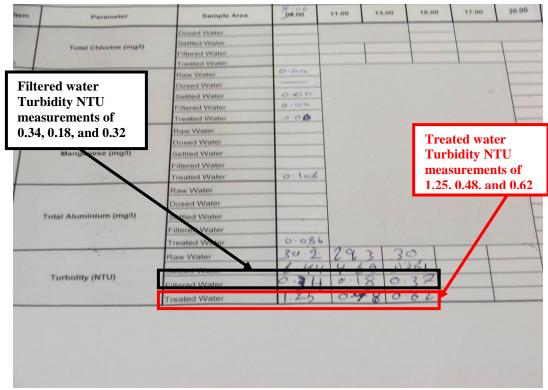
- assorted chemicals for performing tests (Site Photo 6)
- scale
- drving oven
- water sampling basin (Site Photo 7) and water test results (Site Photo 8)
- turbidity meter
- PH meter
- spectrometer
- photo meter
- controller
- glassware

While in the laboratory, SIGIR requested the current day's test results. The daily report for the day of our site visit, 17 September 2008, stated testing was performed at several points throughout the day. The results appeared to be consistent with the project's requirements for finished water quality standards. Specifically, the filtered water NTU readings were within the guidelines established. While the finished water NTU readings were slightly higher, it appears to be a result of an effort to increase the amount of water available to the distribution system (i.e. filtered water was combined with non-treated water). All filtered and finished water readings were well under the WHO standard of 5 NTU.

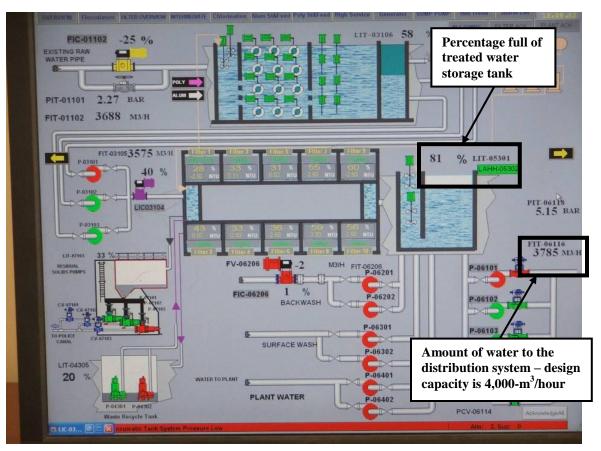
Site Photo 9. PLC control monitor

A Programmable Logic Control (PLC) system allows the WTP operators to monitor the status of the facility with real-time information supplied by sensors and controllers installed throughout the WTP processes (Site Photo 9). The operators can open and close valves, turn on and off pumps, and start and stop mixers as necessary to control the treatment process. Alarm conditions are set initially in the system to let the operator know when a reading is out of normal operating range. SIGIR observed that the PLC system monitors were reporting that the flow from the WTP to the distribution system was 3,785-m3/hr, which means the WTP was operating at 95% capacity (3,785/4,000-m3/hr). All ten filters appeared to be in use and the treated water storage tank was 81% full. An alarm condition due to low pressure in the hydro pneumatic tank was reported during the inspection.

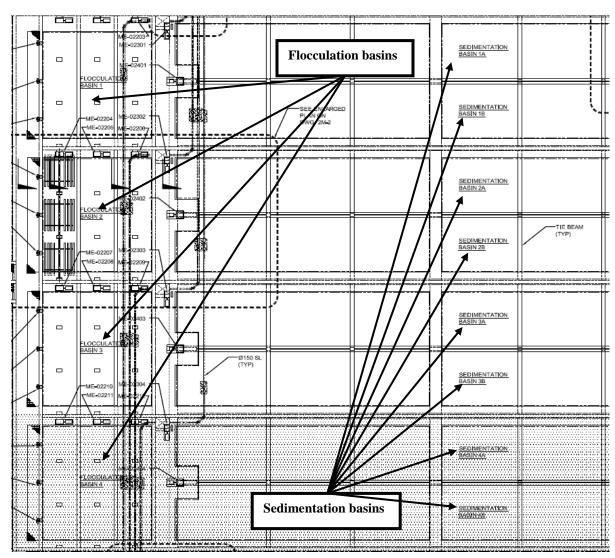
Figure 4. Flocculation/sedimentation basins

The water/chemical solution is channeled to the four reinforced concrete flocculation basins (Figure 4 and Site Photo 13) in which each basin includes three sluice gates, three paddle wheel type flocculators separated by three perforated diffuser walls, and a dual drive chain and flight sludge collector system.
